TECHNICAL MEMORANDUM

Date: September 11, 2024
To: Theresa Perron, Town of Glover
From: Michael P. Hildenbrand, P.E. (D&K)
Cc: Charles W. Johnston, P.E. (D&K), Steve Hanna (Vermont Dam Safety)
Subject: Shadow Lake Dam
Sinkhole Investigation and Temporary Repair

SUBJECT: July 2024 Flood Inspection and Recommendations
Shadow Lake Dam (State ID No. 81.02), Glover, Vermont
SIGNIFICANT Hazard Potential

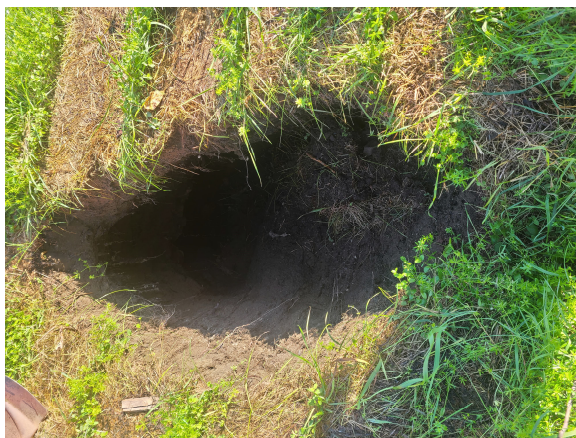
Figure 1 – Sinkhole

The sinkhole is approximately 3 feet downstream from the dam crest and centered between the auxiliary spillway and the principal spillway gate house. The sinkhole (Figure 1) was observed to be approximately 2 feet wide, 4 feet long, and up to about 6 feet deep. The depth varied with the deeper end to the left side and shallower to the right side.

D&K provided a brief outline of a repair option consisting of placing non-woven geotextile into the bottom of the sinkhole and approximately 1 foot up the sidewalls of the sinkhole. The sinkhole was then filled with 1 ½" crushed stone. A Town crew placed the geotextile and began backfilling the sinkhole while D&K personnel were onsite.

The above repair is only considered temporary and a comprehensive repair to restore the embankment to its condition before the emergence of the sinkhole will be required. It is our understanding that a Dam Safety Order will be required to proceed with the repair and that a comprehensive geotechnical investigation and analysis will be necessary to support the repair efforts. Vermont Dam Safety Program has mandated that the Town maintain the lake level approximately two feet below the normal pool due to the presence of a sinkhole in the dam. Until this repair is complete, the Town should not raise the water level. The next steps are to perform additional site investigation including obtaining subsurface soils data to support a Dam Order Application.

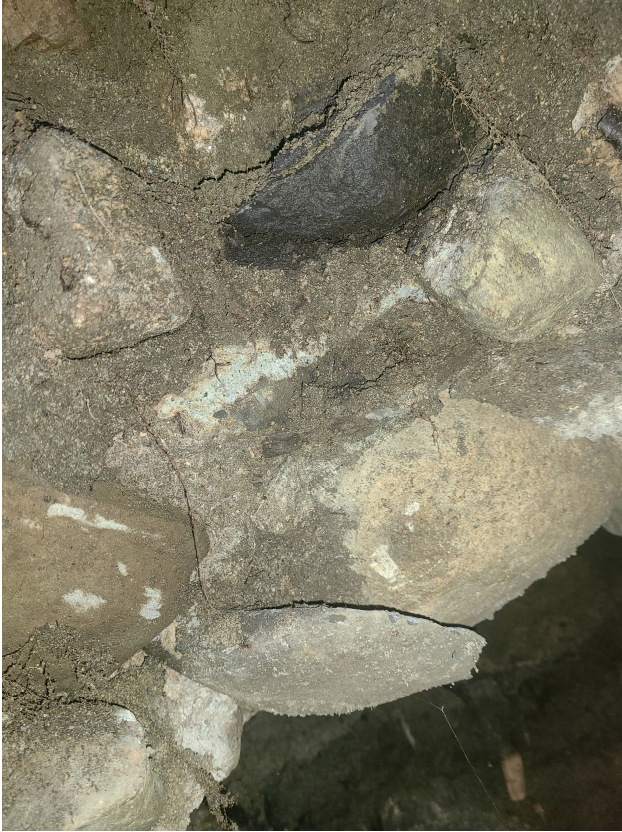
Figure 2 – Masonry Stone

Stone with a concrete grout was observed in the lower section of the sinkhole (Figures 2 & 3). The stone may have provided a barrier to the sinkhole from being in a vertical alignment instead of the observed angled orientation.

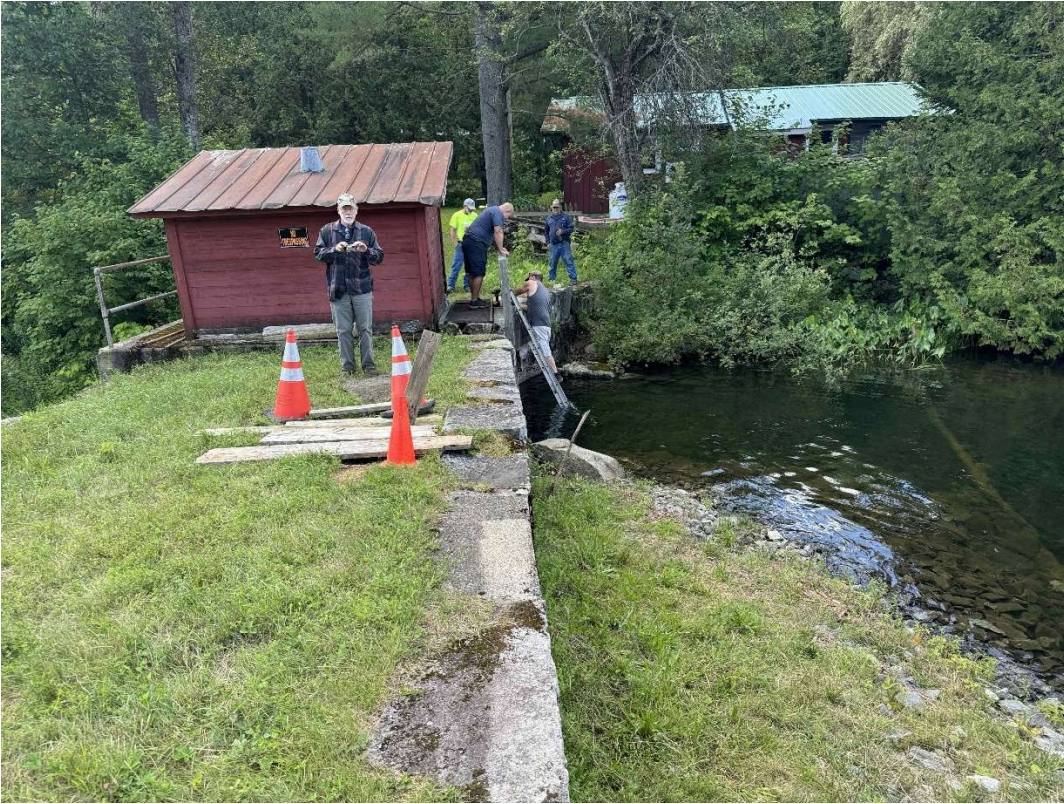
2. At the time of the inspection the owner was in the process of removing two timbers from the principal spillway debris rack to allow for increased discharge. This work was completed by the end of the inspection.

Photo 1: Dam crest, sinkhole, principal spillway derbis rack timber removal (looking towards right abutment).

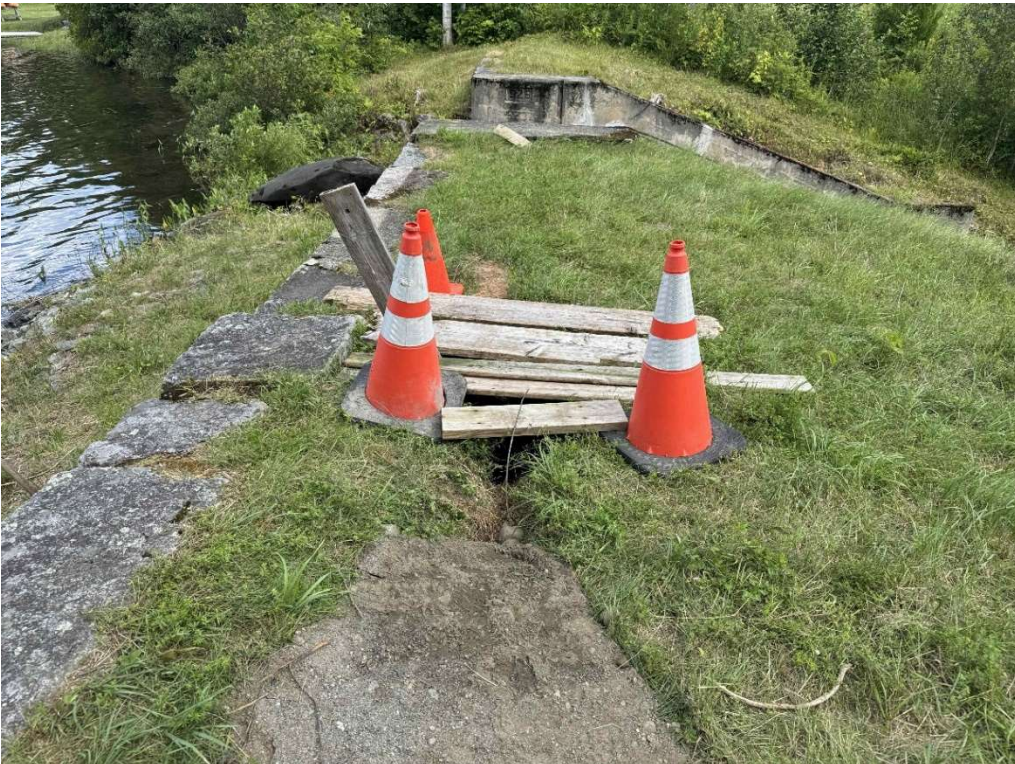
1. The sinkhole along the dam crest identified in the July 18, 2023 Rapid Inspection has increased considerably in size and depth. The sinkhole was measured to be approximately 5 feet in diameter and 5 feet deep. The owner was present during the inspection and noted that they were able to see active flow within the sinkhole during a previous site visit. It is therefore likely that the sinkhole extends into the dam embankment beyond what is visible. In addition to the sinkhole located on the dam crest, the owner showed the DSP a depression along the upstream face of the masonry block wall in close vicinity to the dam crest sinkhole. The owner indicated that the depression may be a location where water was seepage past the upstream masonry wall. It was noted that the masonry block wall has numerous additional un-mortared joints/gaps for water to seep through. The owner also pointed out that the sinkhole appeared to be expanding towards the direction of the bottom of the concrete auxiliary spillway. Historically, seepage flows have been observed at the base of this spillway. While it could not be confirmed that these two locations are directly connected, seepage flow was again observed below the base of the auxiliary spillway at the time of the inspection. The observed seepage was warm to the touch indicating it was likely near surface water from the lake and was flowing through the dam with a short travel time. The seepage did not appear cloudy or to be transporting embankment materials. Due to the location of the seepage, it was not possible to measure the flow rate but it was visually estimated to be 10 to 20 gallons per minute.

Photo 2: Dam crest, sink hole (looking towards left abutment).

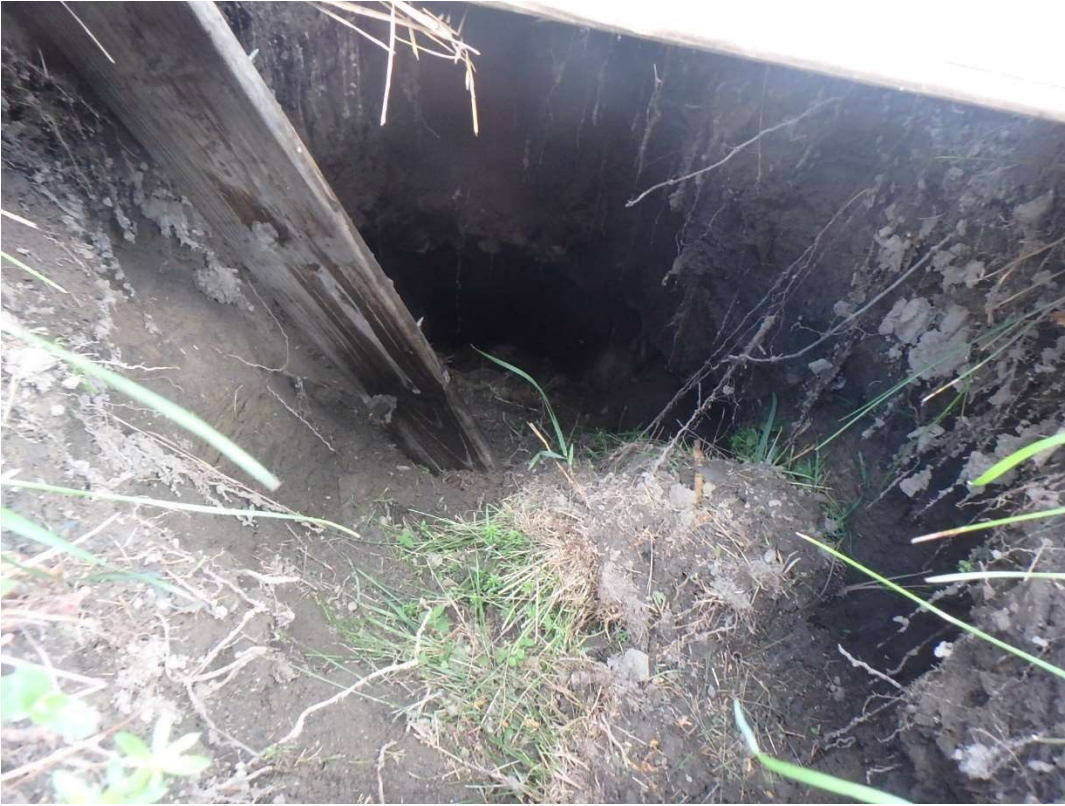
Based on the increased severity of the sinkhole in comparison to the previous inspection and the potential for this sinkhole to lead to seepage/internal erosion/stability issues with the dam, the condition of the dam is downgraded to **UNSATISFACTORY**. Given the **UNSATISFACTORY condition of the dam and the increased potential for an adverse issue**, the DSP is requesting the owner take the following actions:

Photo 3: Sinkhole on dam crest.

1. Continue to regularly monitor the dam and report any unusual/unsafe conditions to the DSP.
2. Without delay, temporarily lower the water level until the sinkhole and other seepage pathways have been thoroughly investigated and repaired in accordance with an engineered and approved solution.

- Systematically remove stoplogs to provide a minimum of 2 feet of drawdown in the lake to reduce loading on the dam and reduce seepage pressures in the embankment. This can likely be achieved by removing one stoplog from the principal spillway structure and once the water level has stabilized, additional stoplogs as needed.

4. Retain an Engineer experienced in the evaluation and design of dams to evaluate the sinkhole, seepage, and stability of the dam. This work should include field investigations to determine the source and severity of seepage, explore the type and consistency of the embankment and foundation soils and rock, and evaluate the seepage and structural stability of the dam. The work should also identify potential repair alternatives for review.

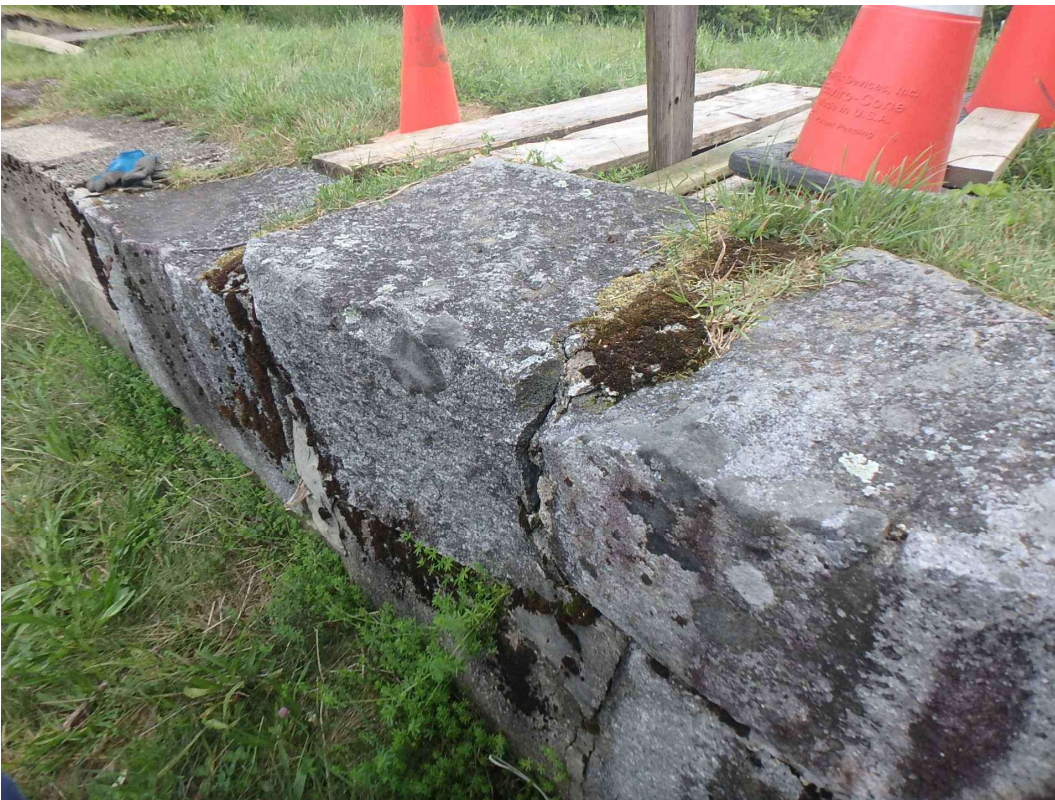
Photo 4: Example masonry blocks and gaps between joints upstream of sinkhole location.

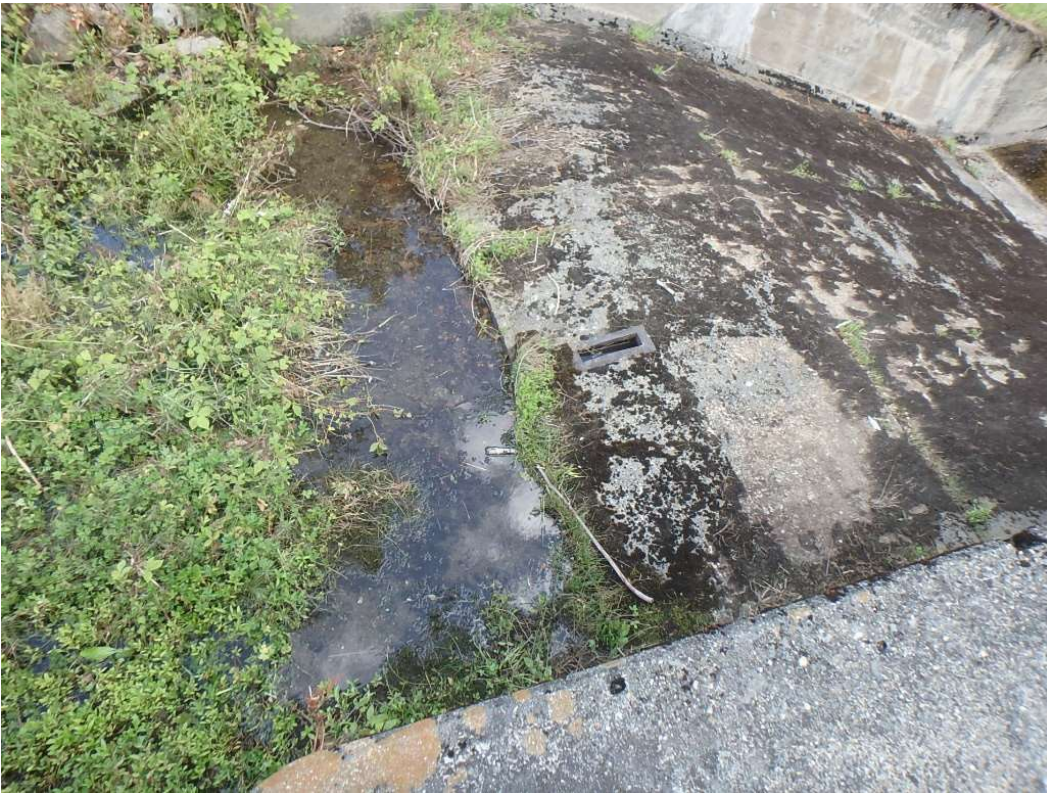
Photo 5: Lake level a few inches below auxiliary spillway crest at the time of the inspection.

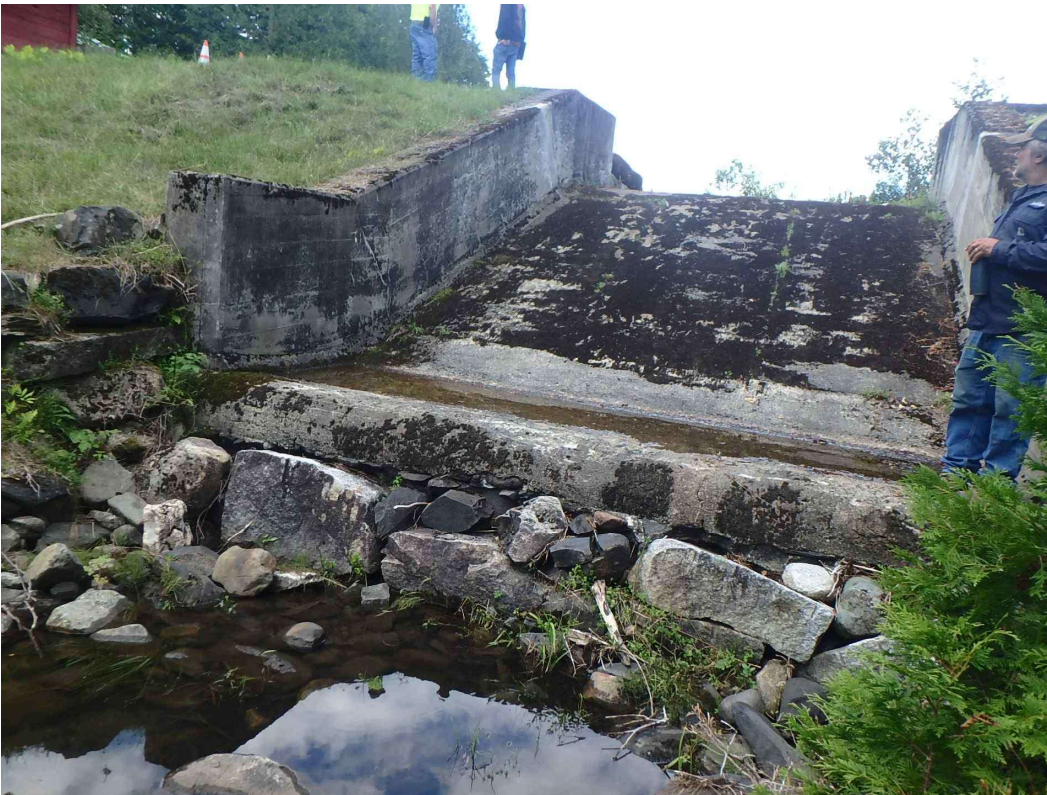
Photo 6: Water pooled below base of auxiliary spillway.

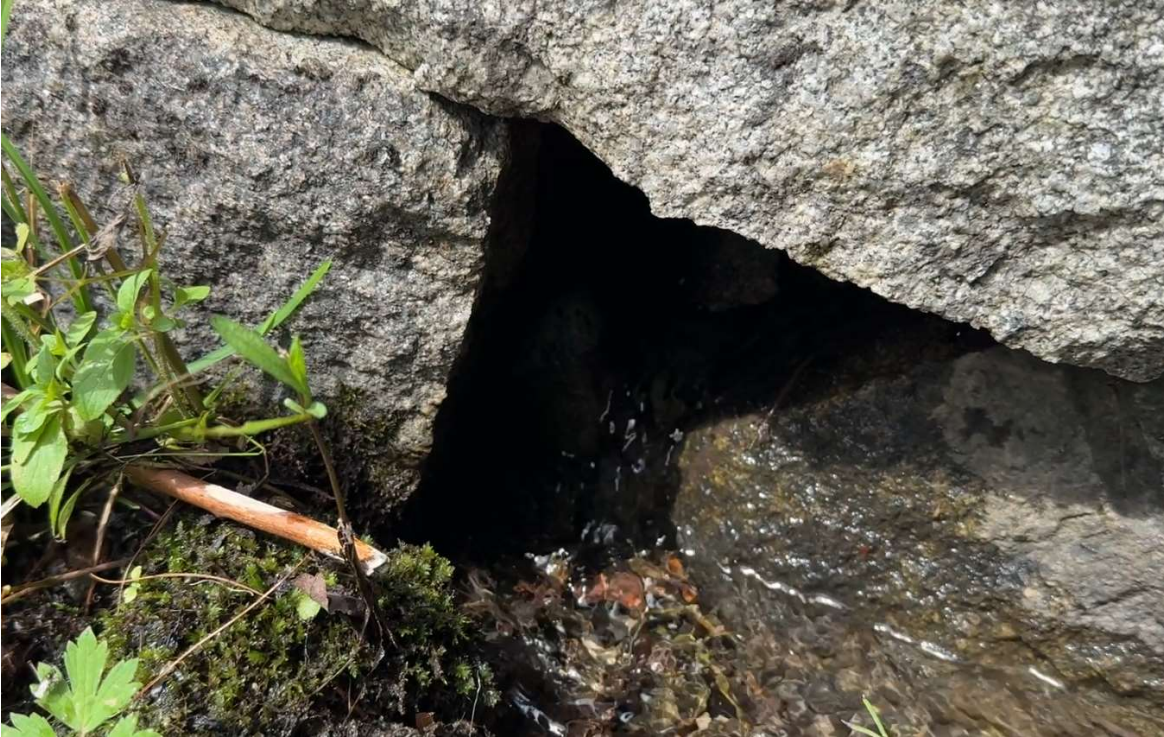
Photo 7: Seepage flow emanating from stones below base of auxiliary spillway.

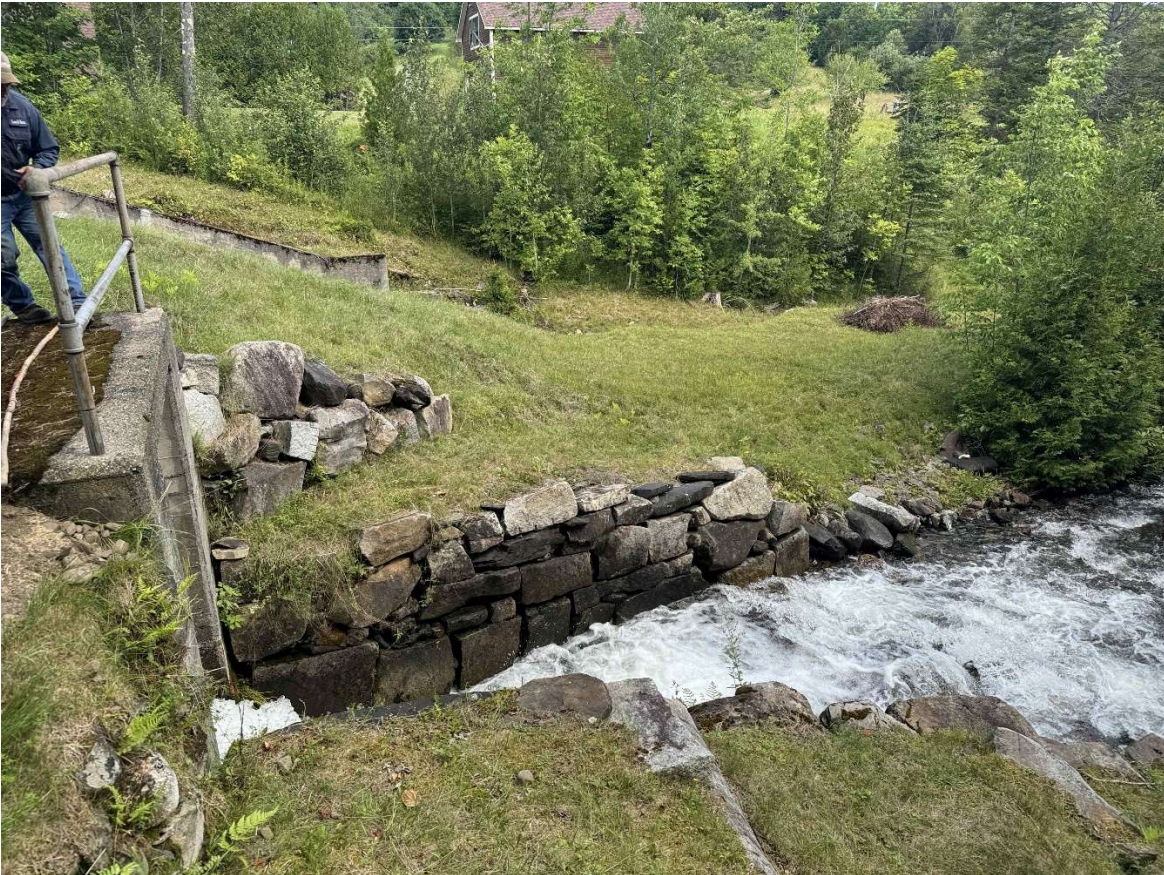
Photo 8: Downstream slope standing on right side of dam looking towards left side of dam.
