Water Investment Division
Dam Safety Program
1 National Life Drive, Davis 3
Montpelier, VT 05620
Phone: 802-622-4093

MEMORANDUM

SUBJECT: Site Visit Report
Shadow Lake Dam (State ID No. 81.02), Glover, Vermont
SIGNIFICANT Hazard Potential

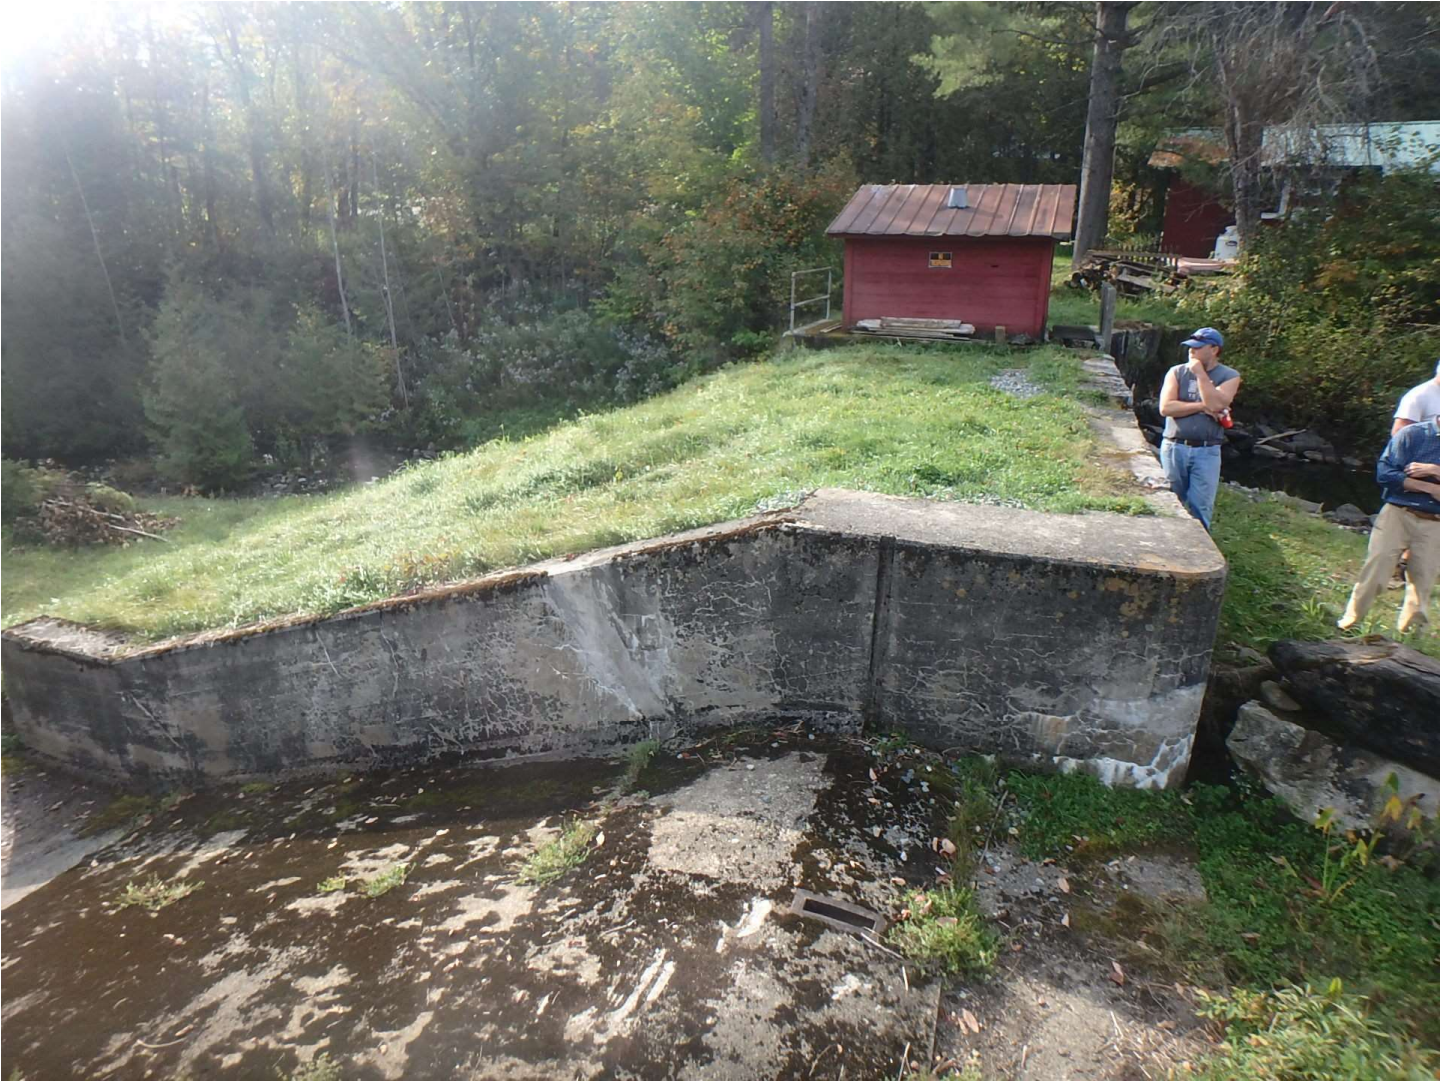
- The area of the sinkhole that was temporarily repaired and overseen by D&K was observed and appeared to be firm and stable. The crushed stone backfill used to make the repair could be observed at ground surface.

Photo 1: The dam from the auxiliary spillway looking at the gatehouse. The temporary sinkhole repair on the crest can be seen.

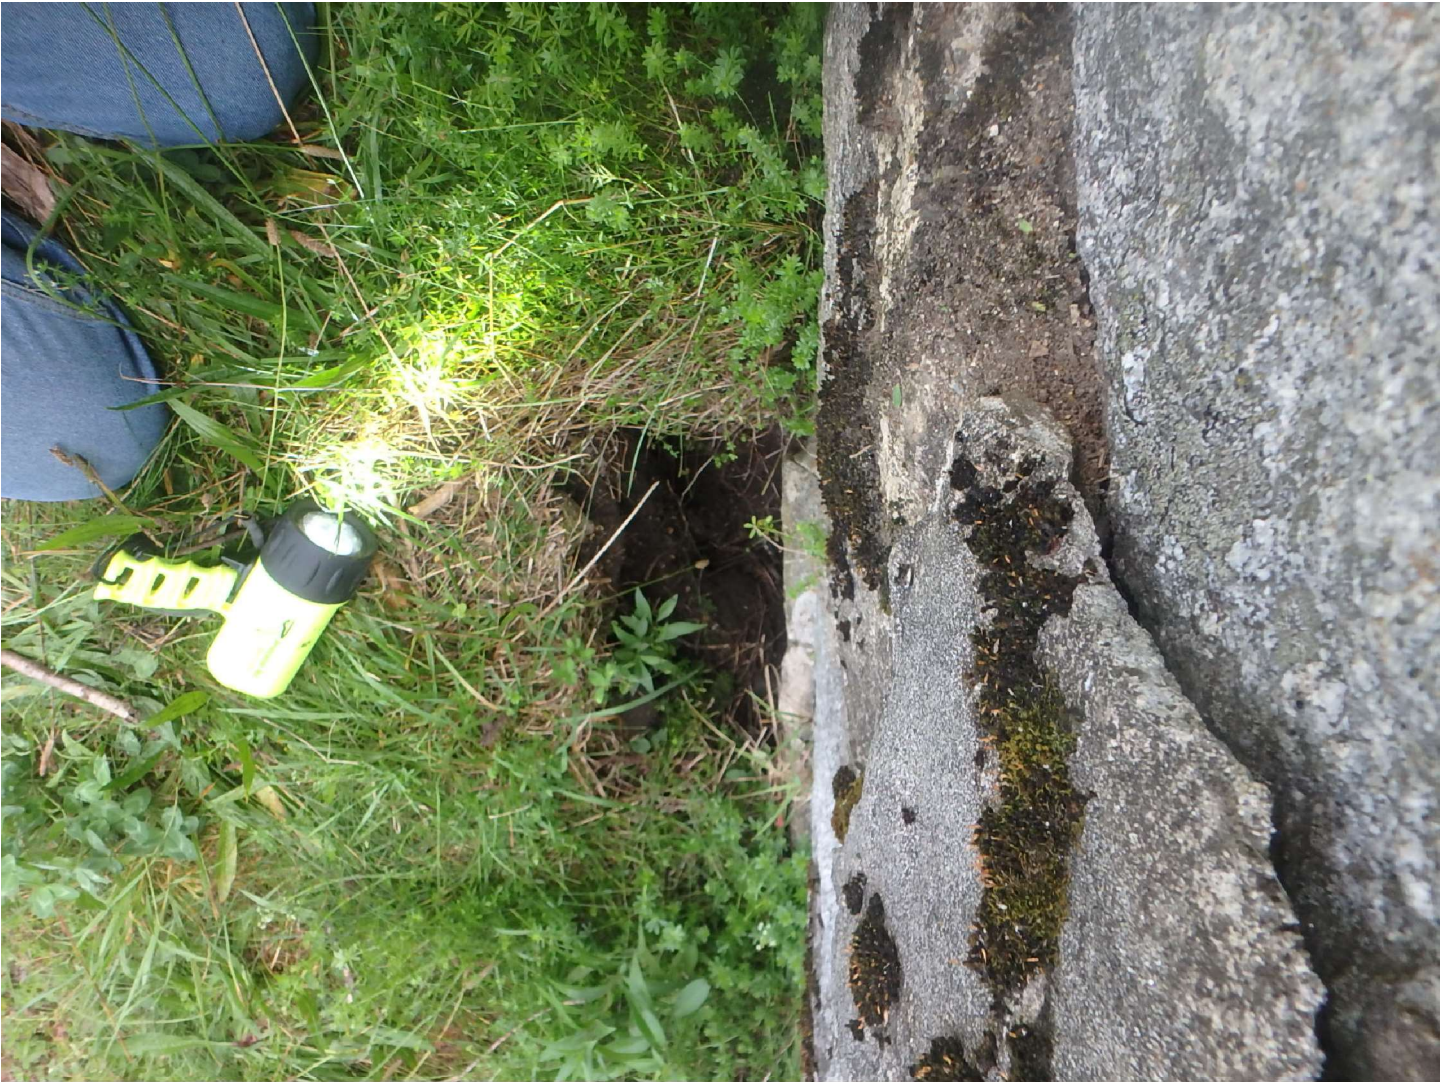
- Upstream of the sinkhole location, the DSP was directed to a new, small sinkhole located on the upstream side of the granite masonry wall. The sinkhole was approximately 6 inches wide (upstream to downstream), 18 inches

Photo 2: Small sinkhole upstream of the stone masonry wall near the existing sinkhole.

long (left to right), and appeared to be over 24 inches deep and angled towards the auxiliary spillway. The DSP recommended that this small sinkhole be over-excavated and backfilled with crushed stone encased in filter fabric like the original sinkhole temporary repair.

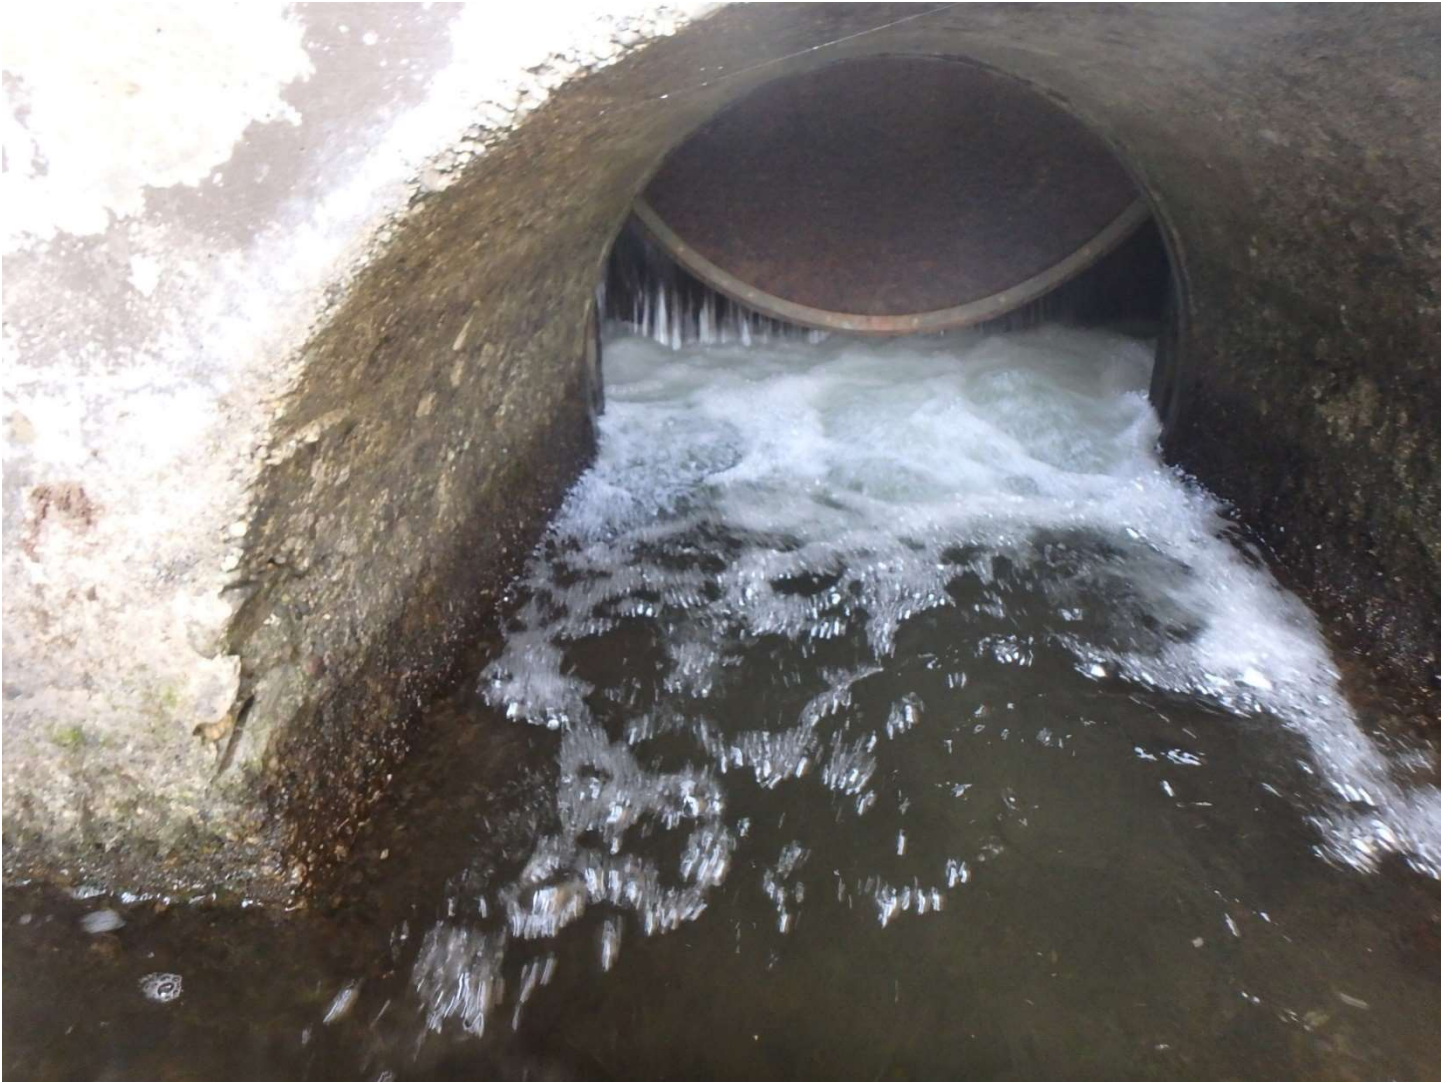
- The face mounted metal slide gate is located approximately 37 inches downstream of the stoplogs. The gate sides appeared to be properly situated in the guide channels. The gate was test operated to nearly fully closed and back to its typically maximum opening position, which was measured to be approximately 21 inches above the invert of the 36-inch diameter concrete discharge pipe (or 15 inches protruding into the opening) downstream of gate. The gate operated smoothly through this range and did not appear to have any areas of binding. The reason for the gate not opening clear of the 36-inch pipe were investigated. The top of the rising stem did not appear to have interference and the gate itself did not appear to reach a stop point. It was surmised that perhaps the bottom end of the threaded stem is reached at its current maximum opening position and that is the reason it cannot be opened clear. While this could not be visually confirmed as it is in the internal workings of the gate, the theory appears credible. Jack Sumberg reported that the configuration of the gate has been unchanged since his involvement in dam operations in 2012.

Photo 3: The gate plate extending into the 36 inch concrete pipe waterway opening. From the invert of the pipe to the bottom of the plate was measured to be approximately 21 inches. From the bottom of the plate to the crown of the pipe was measured to be approximately 15 inches.

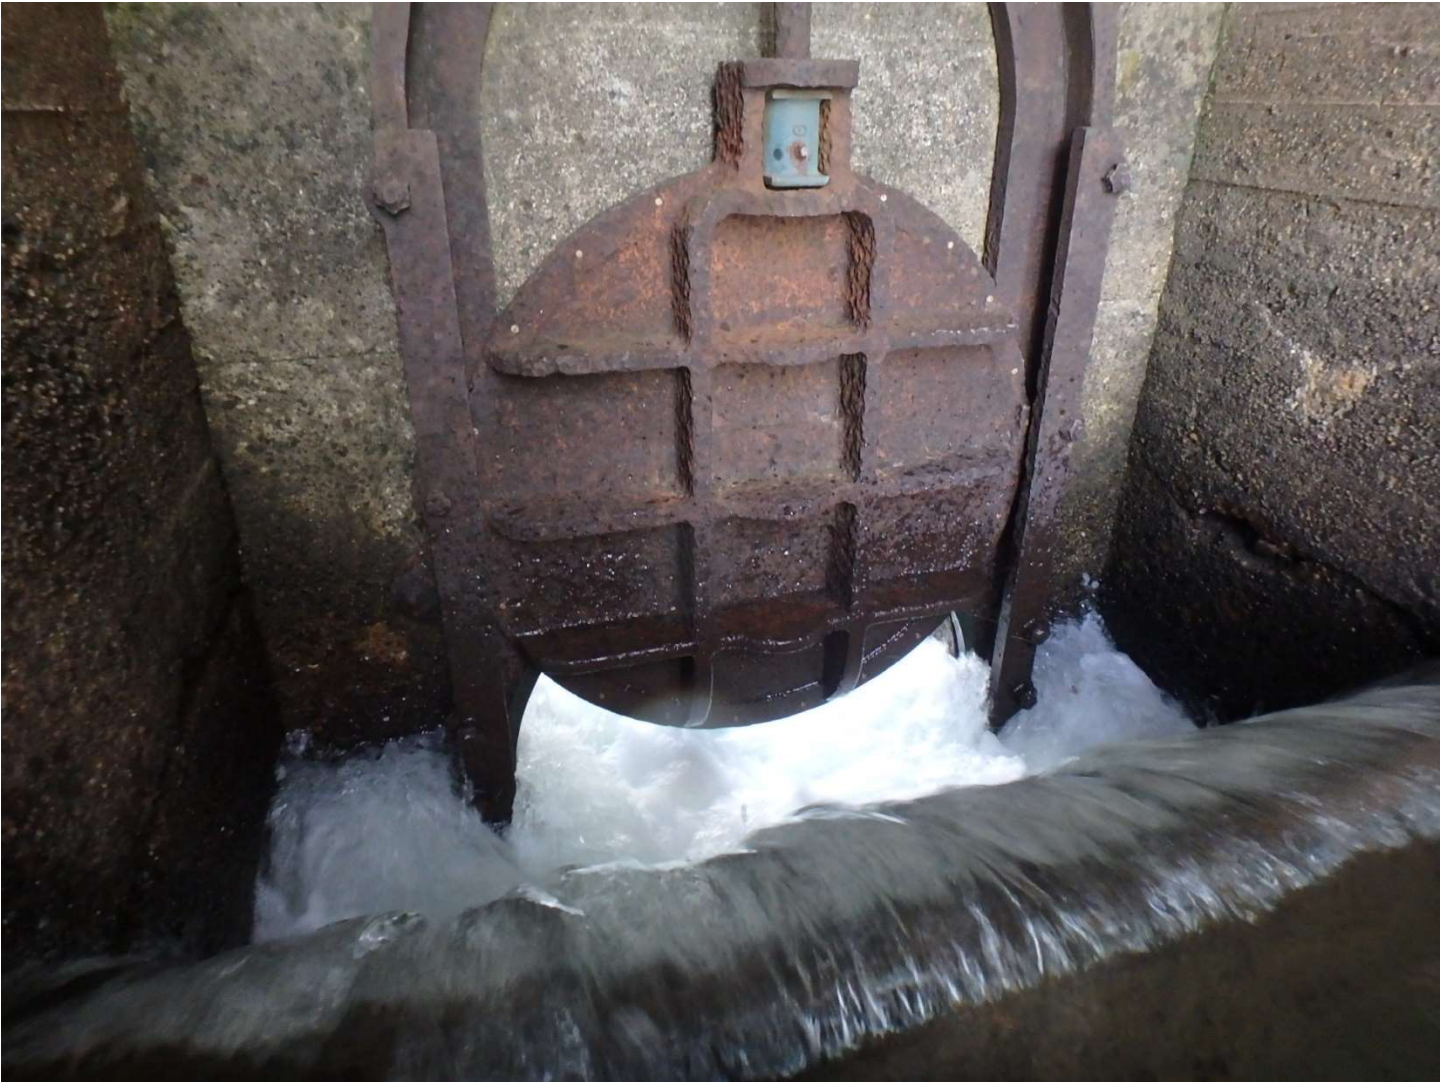
Photo 4: The gate downstream of the stoplogs looking downstream.

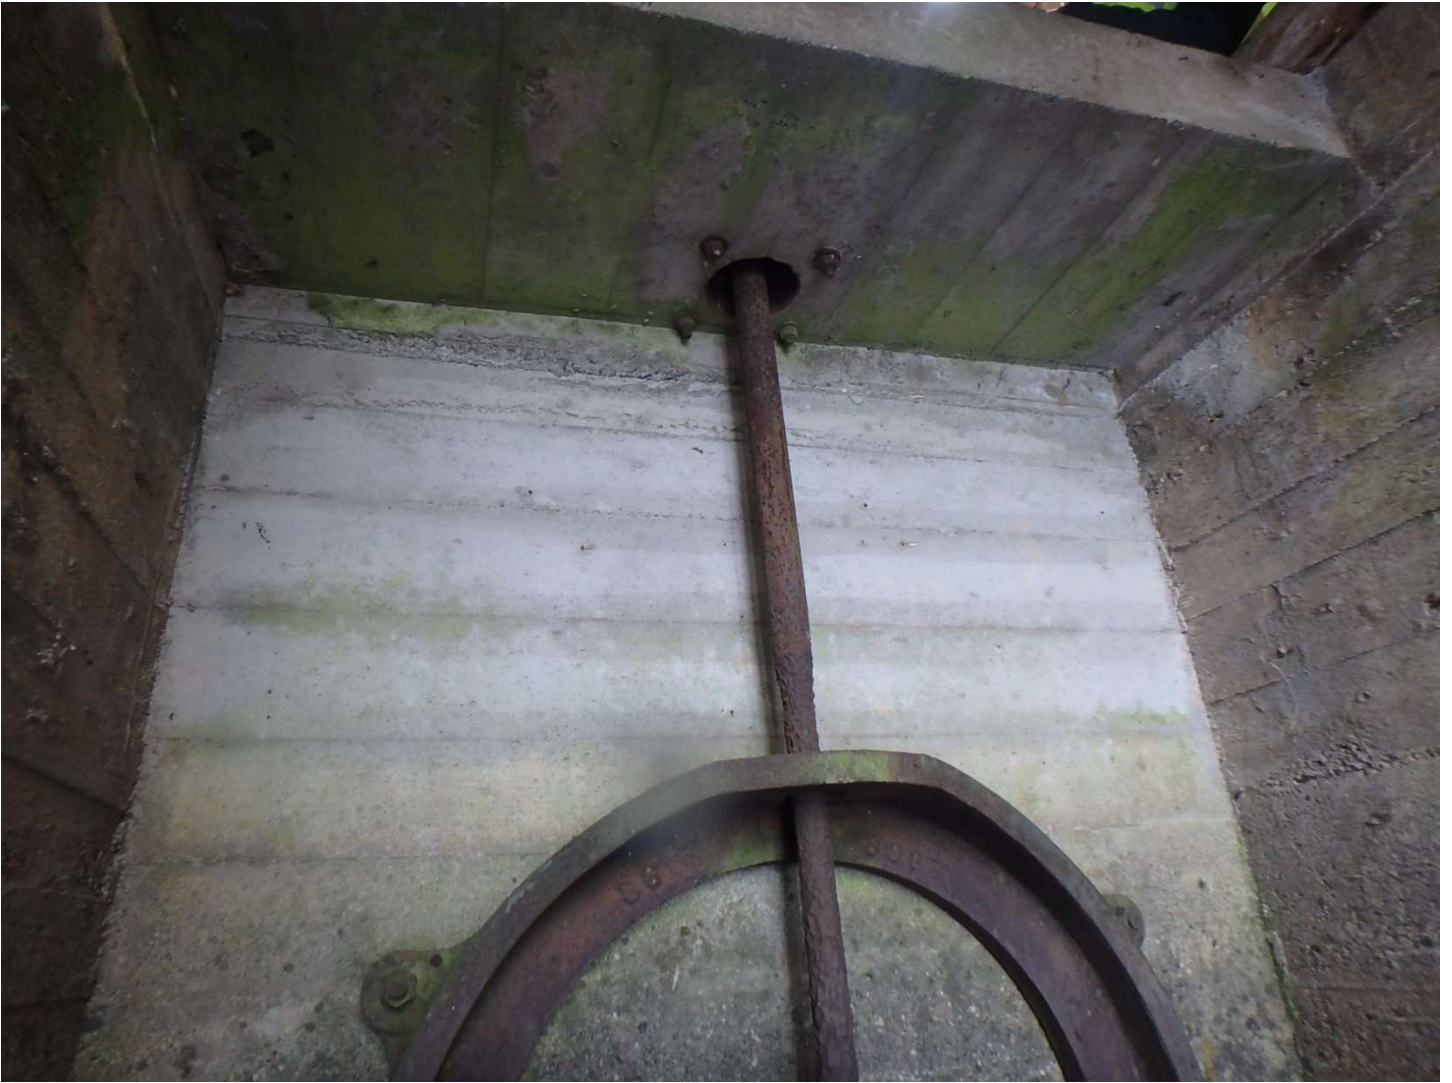
Photo 5: The gate stem where it enters the floor, above.

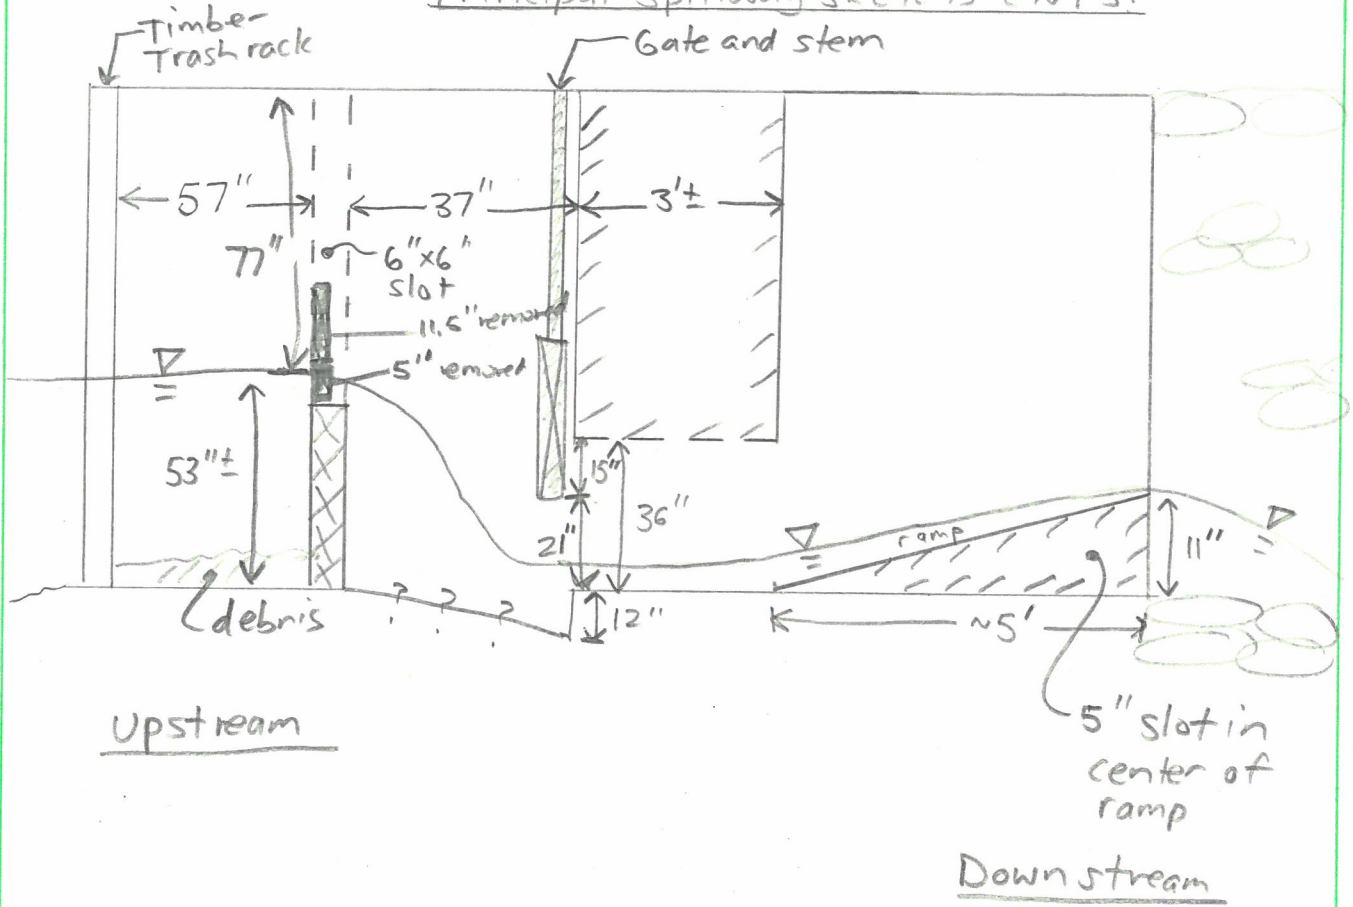
Principal Spillway sketches (NTS)

- The Town provided access to the gatehouse and the DSP made the following observations (see attached site sketch):
 - As noted in the previous report, two of the 4 inches by 4-inch vertical timbers comprising the trash rack at the spillway inlet have been removed with 7 timbers now remaining. The concrete principal spillway channel has a total width of approximately 65 inches. Based on field measurements, the cumulative opening between the vertical timbers was measured to be approximately 43.5 inches (from right to left in inches, 4.5, 13, 4.5, 4.5, 12, 5). It should be noted that based on these measurements, approximately 67% of the channel width is available for flow. It should be noted that a horizontally oriented 3 inch by 7-inch timber was noted near the normal water line spanning the channel width as well.

- From the trash track, the stoplogs are approximately 57 inches downstream.
 - A height of approximately 53 inches of stoplogs were installed in the slots when we arrived onsite. Debris in the approach channel made obtaining an accurate measurement difficult. The slots in the concrete to support the stoplogs are 6 inches by 6 inches. The top stoplog was measured to be a 5-inch-high rough-cut timber. The next stoplog appeared to be approximately 12 inches in height. The dimensions of the lower stoplogs could not be measured in the flowing water. At this time, the 5-inch high stoplog was removed in an effort to reach the 2-foot drawdown target recommended in the July 26, 2024, Report. The stoplog was removed with normal effort. It was recommended to the Town that once flows stabilize over the stoplogs, that the next approximately 12-inch high stoplog be removed and the 5-inch stoplog (perhaps new stock) be installed to achieve the targeted 2-foot drawdown. The 12-inch appeared to well seat in position. If typical removal techniques are unsuccessful, alternative techniques were discussed such as cutting it out (taking care not to cut past that stoplog) and/or partially closing the gate to equalize water pressure (with appropriate staff safety considerations taken into account). The Town indicated they would plan to perform these operations soon. Jack Sumberg, who has been involved with the dam since 2012 indicated that the full stack of stoplogs were replaced roughly 10 years ago, which based on the overall fair condition of the removed 5-inch stoplog, appeared reasonable.

- The length of the 36-inch diameter pipe downstream of the gate was not field measured but appears to be on the order of 3 feet.
 - At the discharge end of the concrete pipe, the discharge channel slopes upwards over a length of approximately 5 feet and a rise of approximately 11 inches. In the center of the ramped section is a 5-inch-wide slot that appears to be graded roughly level. It was surmised that the ramp is likely a means to reduce flow energy.

- Next steps at the dam were discussed and include the following:
 - The Town is to carefully remove the 12-inch stoplog and re-insert a new 5-inch high stoplog to achieve the recommended 2-foot drawdown from the July 26, 2024, Report.
