SHADOW LAKE DAM

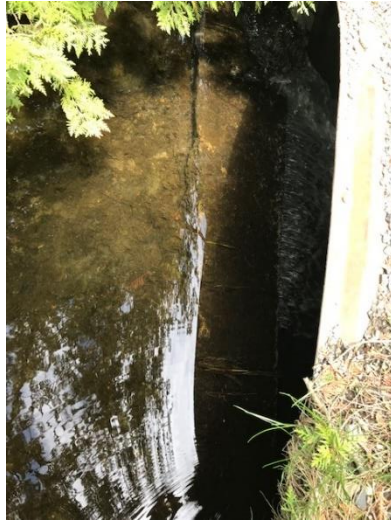
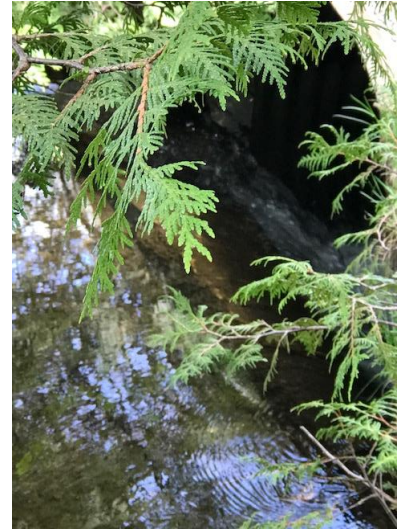
DANIEL'S POND

The Daniels Pond Dam does not appear on the VCGI dams' layer because it consists of a granite block set across the culvert at the outlet which controls the height of the water and is not adjustable. The area was inspected by the mitigation team, May 17, 2024, and noticed it needs debris clean up and cut back some branches that overhang the culvert.

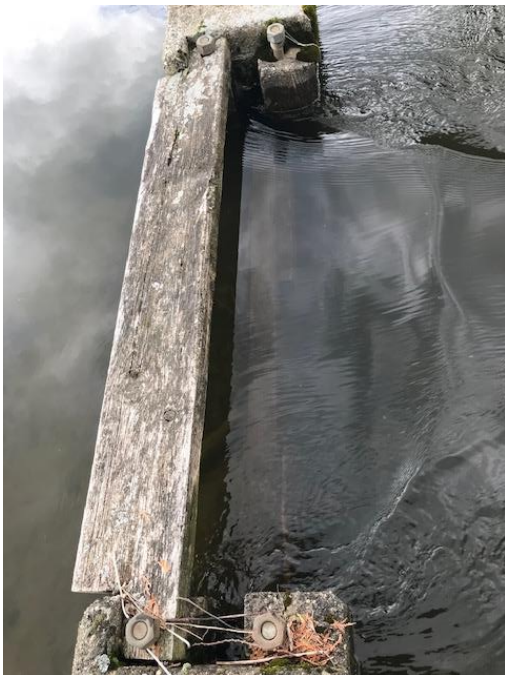
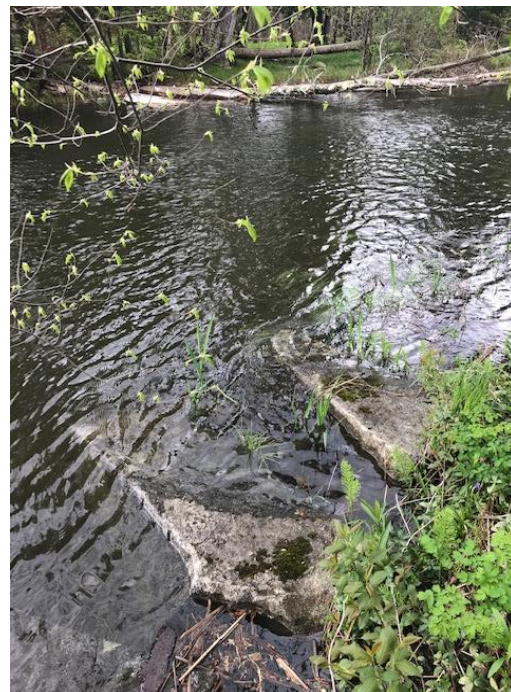
PARKER LAKE:

The Lake Parker dam is a Class 3 “low hazard” dam and, as such, is not considered in this Mitigation Plan. However, upon inspection on May 17, 2024, contact was made to families near the dam to offer help with debris removal. These families will consider doing the work on their own and will notify the town if help is needed. A new top board is needed for the outlet. The town will provide this.
